Re: Remedial Action Monthly Progress Report No. 9 - November 2010
12th Street Landfill Operable Unit No. 4
Allied Paper, Inc./Portage Creek/Kalamazoo River Superfund Site
Allegan and Kalamazoo County

**Remedial Action Progress Report No. 9
November 1, 2010 to November 30, 2010**

**Remedial Design and Remedial Action
12th Street Landfill, Operable Unit No. 4
Otsego, Michigan**

PHOTOGRAPHIC LOG (DATE: NOVEMBER 30, 2010)

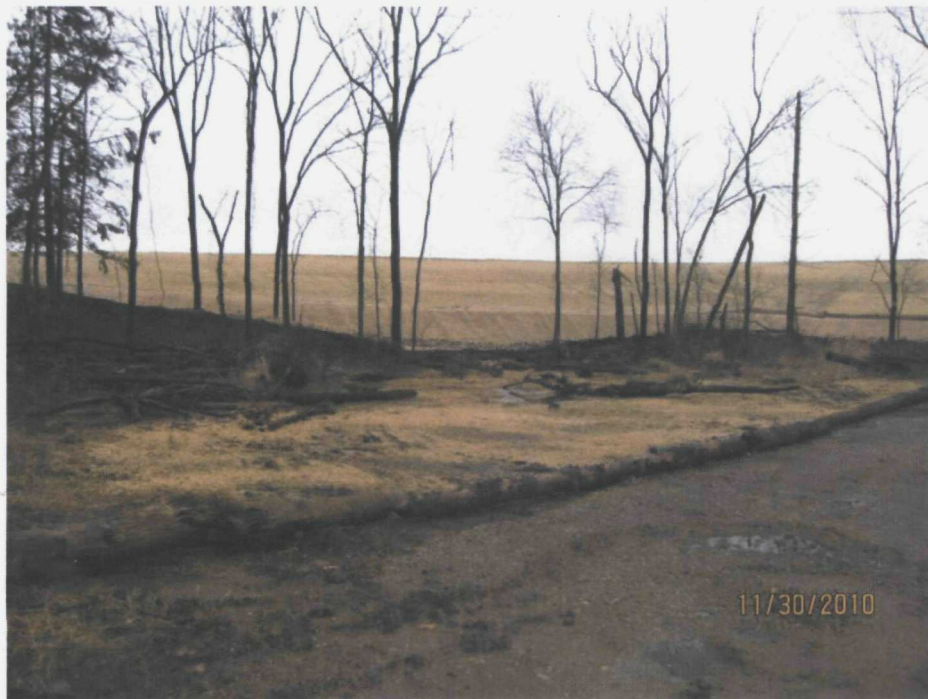
Photo 1: View of MDNRE property, facing northwest

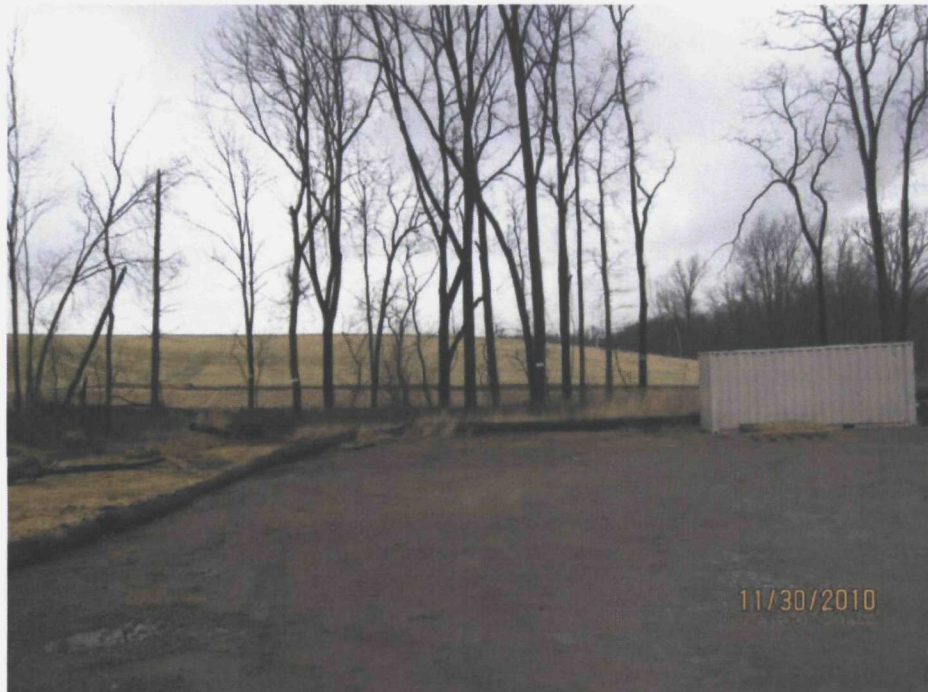
Photo 2: View of landfill and MDNRE property, facing north

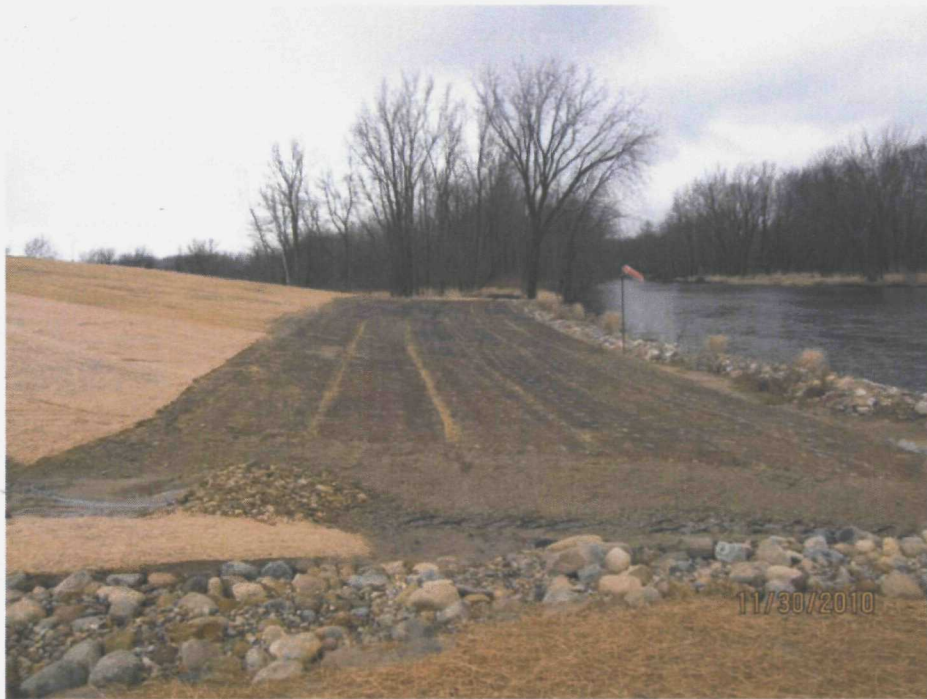
Photo 3: View of turf reinforcement mat installed along east side of Site adjacent to Kalamazoo River, facing north

- Installed turf reinforcement mat in swale areas and along the east side of the Site adjacent to the Kalamazoo River, as specified.
- Constructed three soil wetland platforms at monitoring well locations MW-103, MW-104, and MW-105.

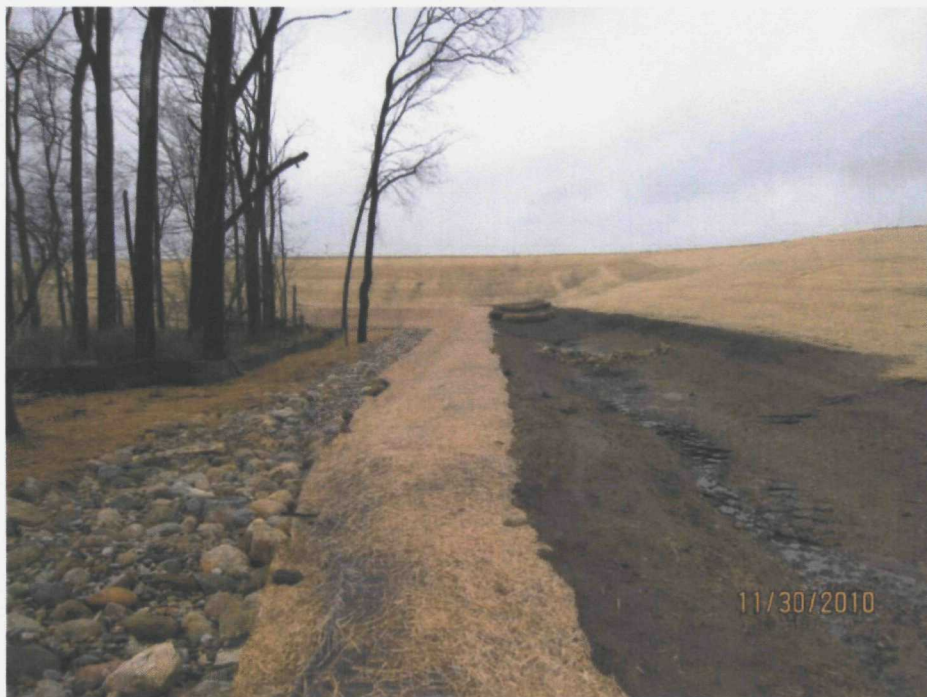
Photo 4: View of erosion control matting along the northern MDNRE property boundary, facing west

- Installed Site security fence.
- Seeded Site and installed three types of erosion control matting from North American Green (S150 on 4H:1V slopes; DS150 from the top of the drainage swale to the wetland area on north side of the Site; and SC250 within the drainage swales on the north side of Site) and straw matting with tackifier on top portions of the landfill as discussed during the Pre-Certification Inspection Meeting.

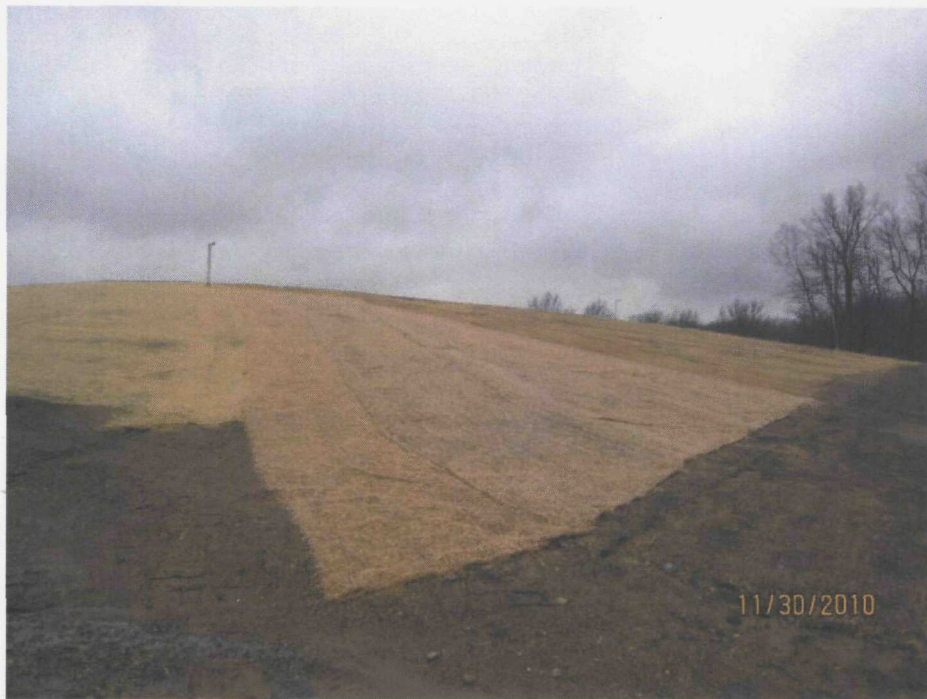
Photo 5: View of erosion control matting on side slopes along east side of Site, facing northwest

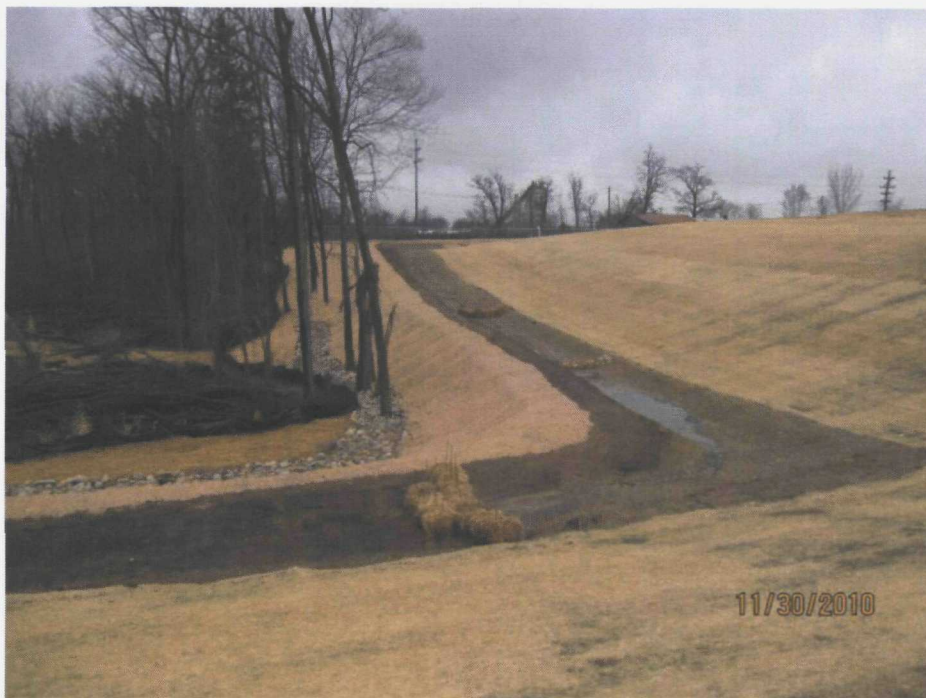
Photo 6: View of erosion control matting along east side of Site adjacent to MDNRE western property boundary, facing south

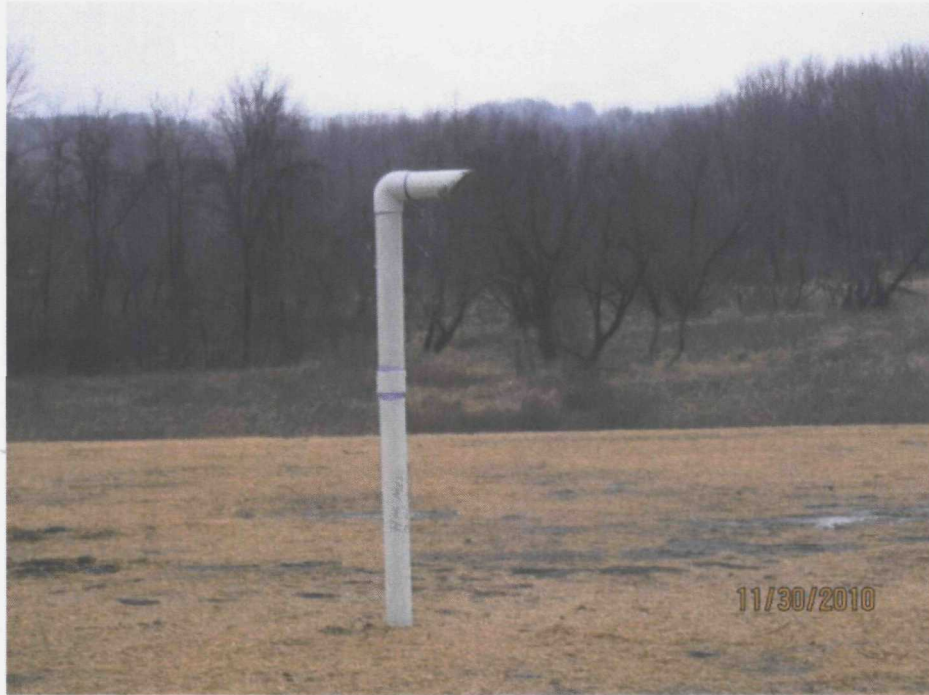
Photo 7: View of piping extension made to gas vent, facing north

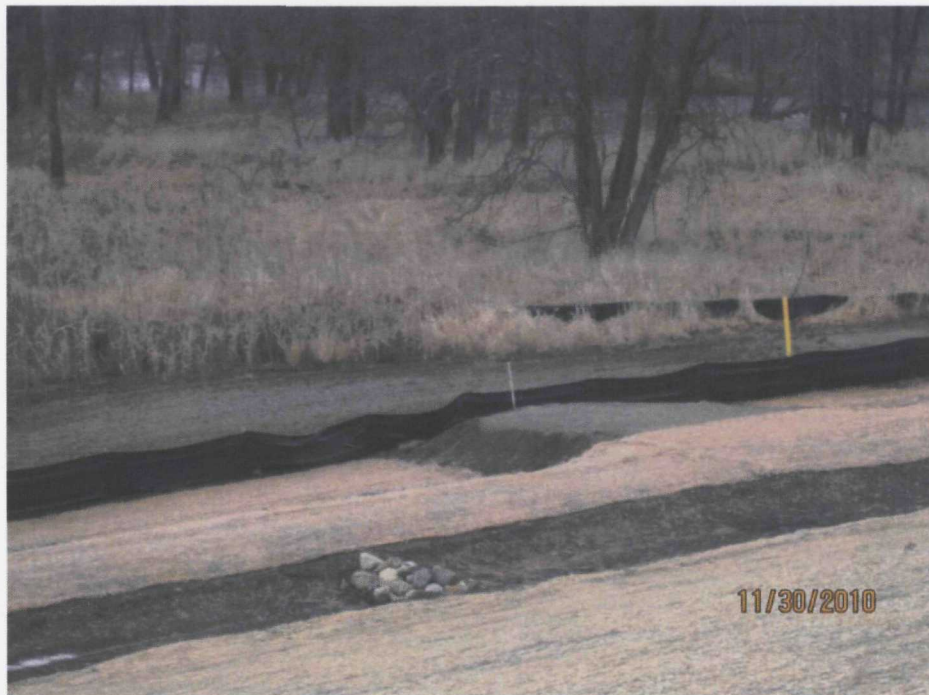
Photo 8: View of soil platform for groundwater monitoring well MW-105, facing northeast

- Soil platforms would prevent surface water infiltration into shallow screened wells
 - Soil platforms would allow for shallow monitoring wells to be constructed and screened at depths approximately 6 inches below ground surface, providing additional support above the screened interval

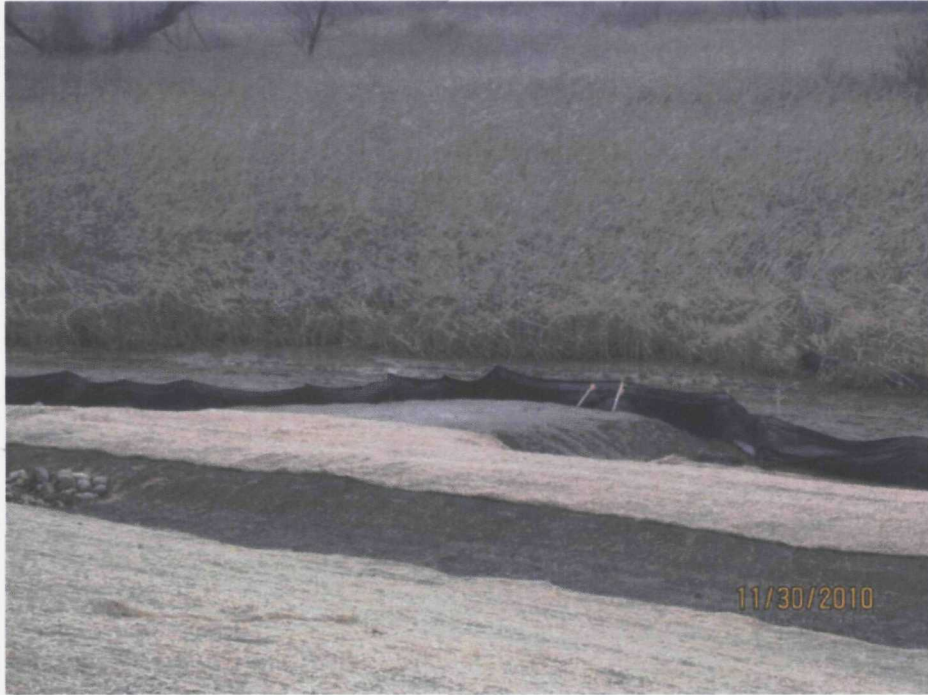
Photo 9: View of soil platform for groundwater monitoring well MW-104, facing northwest

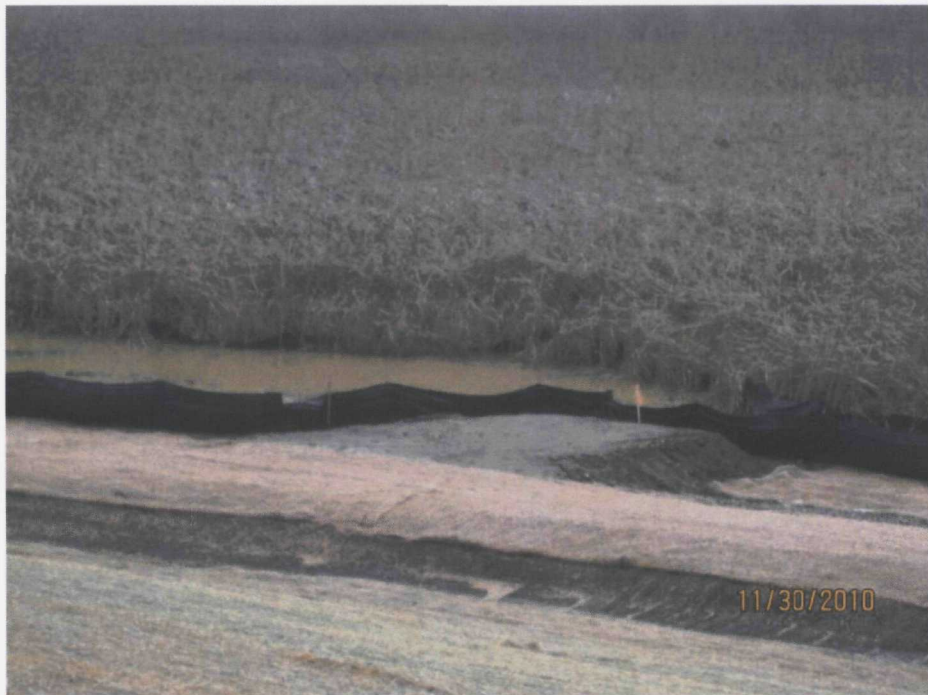
Photo 10: View of soil platform for groundwater monitoring well MW-103, facing west-southwest

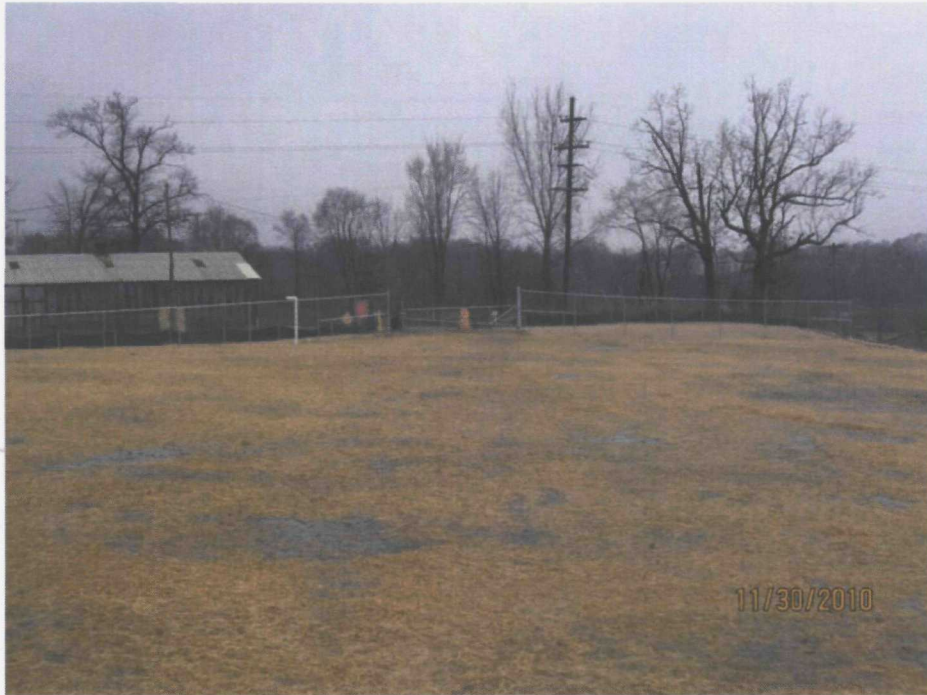
Photo 11: View of straw matting and Site gate, facing south

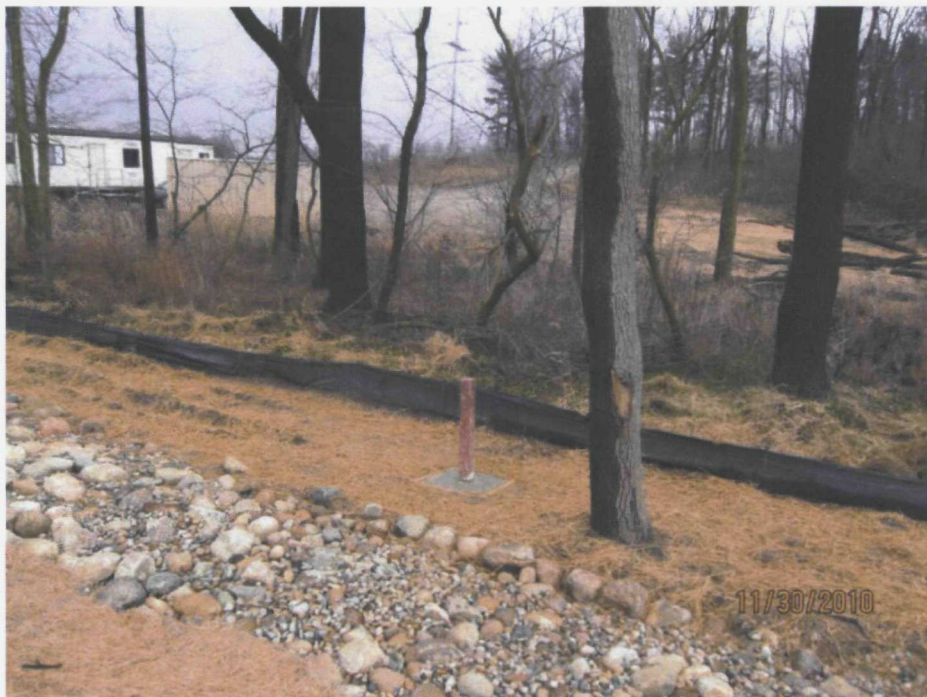
Photo 12: View of gas probe GP-1, facing southeast

- Installed gas probes GP-1 through GP-3.
- Installed chain-link fence and access gates, as specified at the south perimeter of the Site.

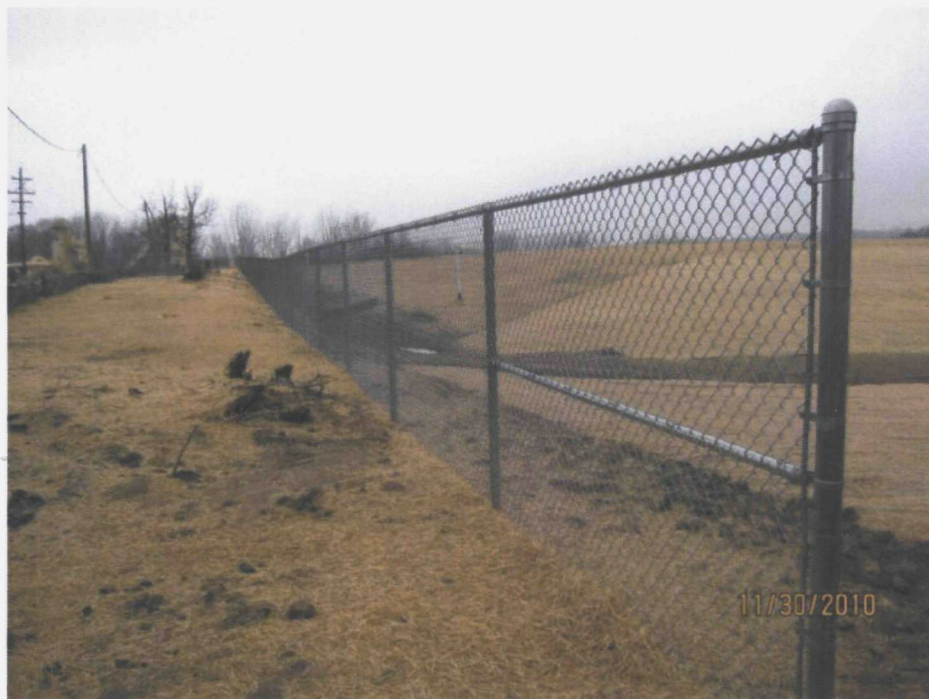
Photo 13: View of Site security fence, facing west

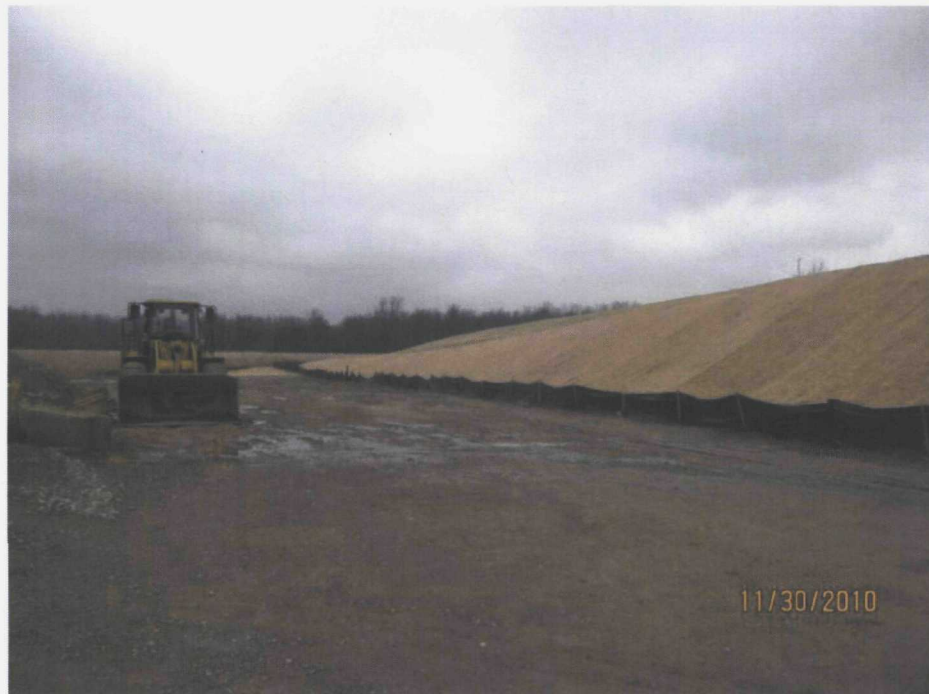
Photo 14: View of erosion control matting on west slope of landfill, facing north

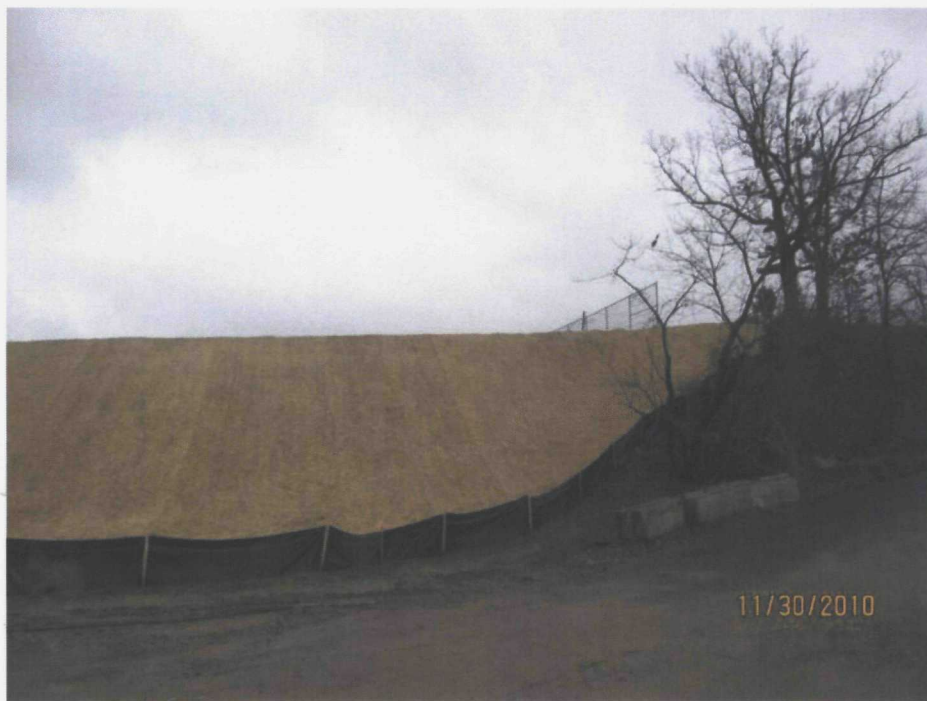
Photo 15: View of erosion control matting on steep slope at southwest corner of landfill, facing east
